Diagnostic Tip - Orientation Of The Rear Wheel Bearing During Installation

2011 - 2015 Chevrolet Caprice PPV

2014 - 2015 Chevrolet SS

2008 - 2009 Pontiac G8

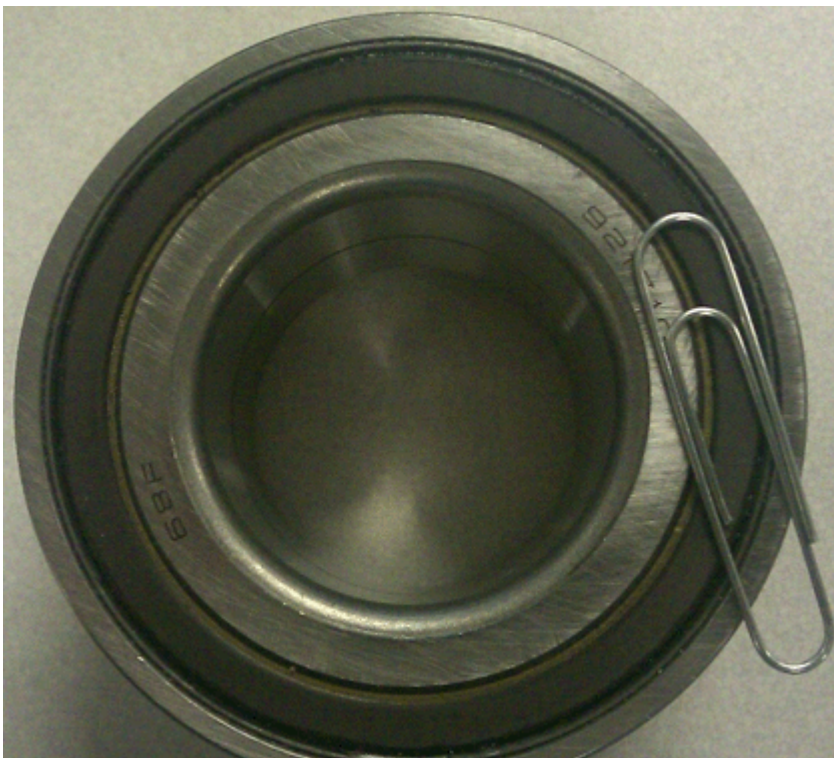
The decoder ring side of the bearing is the side that is both darker in color, and it is also magnetic.

The picture below indicates the decoder ring side. Note that the paper clip is stuck to it because it is magnetic.

Service Information directs the technician to install the wheel bearing so the decoder ring faces inboard towards the wheel speed sensor but does not describe how to determine which side of the bearing is the decoder ring side.

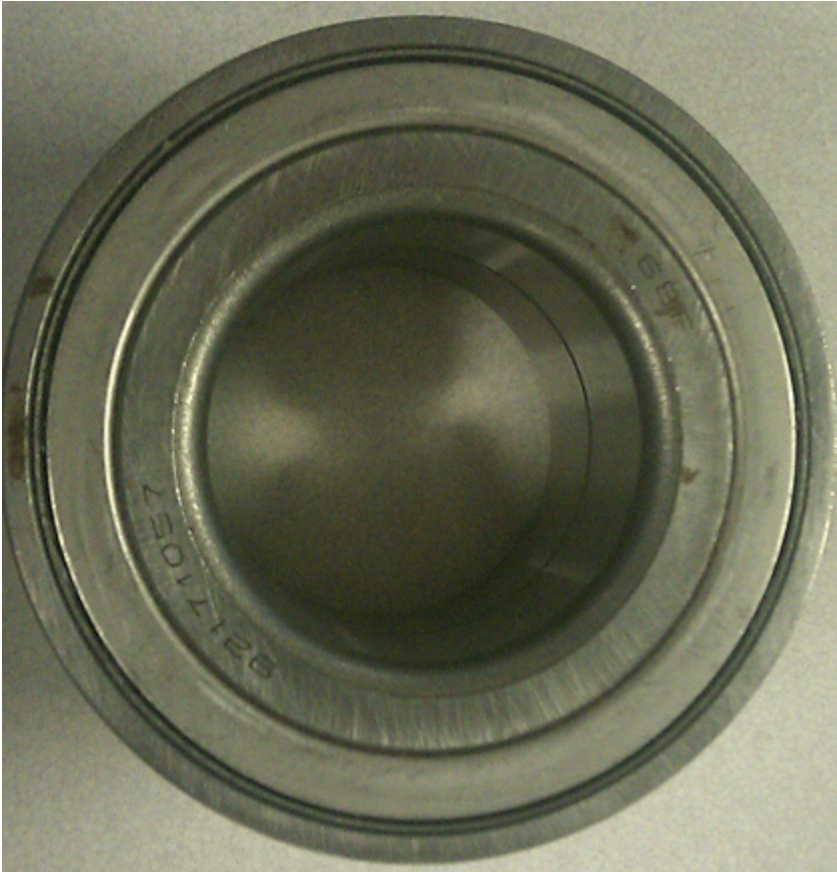
The picture below shows the opposite side of the wheel bearing for reference. This side would be

facing outboard, away from the wheel speed sensor.
