# 14327 – Special Coverage Adjustment – Loss of Steering Due to Water Intrusion (Steering Gear Umbrella Seal Missing)

2004-2005 Chevrolet Malibu, Malibu Maxx

2005 Pontiac G6

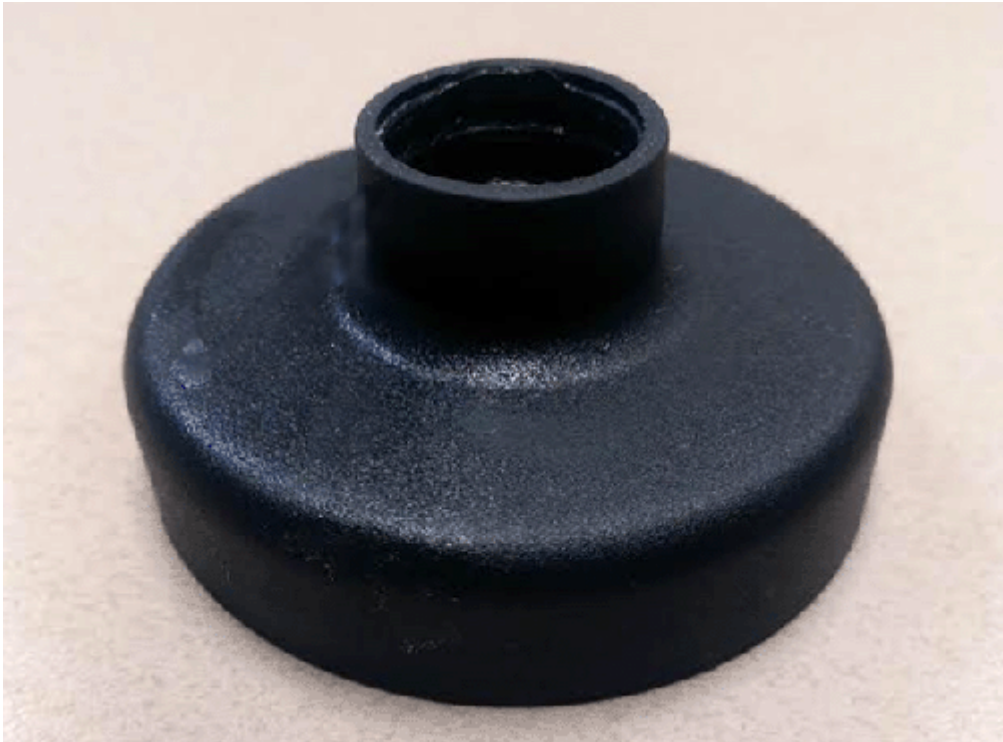
Some 2004-2005 model year Chevrolet Malibu, Malibu Maxx and 2005 model year Pontiac G6 vehicles may have been built without a steering gear umbrella seal. Without the seal, water and dirt may enter the system and could cause the rack and pinion parts to corrode. If corrosion exists, the “feel” of the steering wheel will be loose. If the system is not serviced when the parts become loose to the feel, then the parts could fail, resulting in the steering wheel spinning freely.

Use the following steps to inspect the steering gear input shaft for the presence of an “Umbrella Seal”. If no seal is installed, it will be necessary to replace the steering gear.

Dealers are to replace the steering gear. The repairs will be made at no charge to the customer.

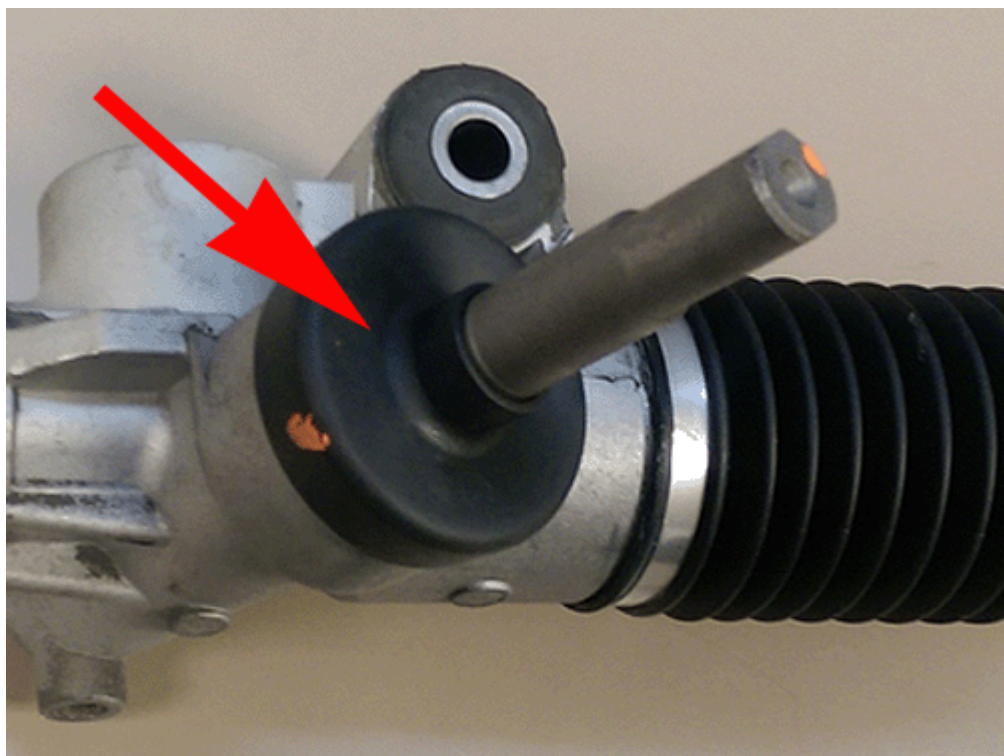
1. Raise and support the vehicle. Refer to in SI.
2. Inspect the input shaft area of the steering gear and determine if the seal is installed.

If the seal is installed, no further action is required. Inform the customer that any

additional diagnosis and repairs are not covered under this special coverage.

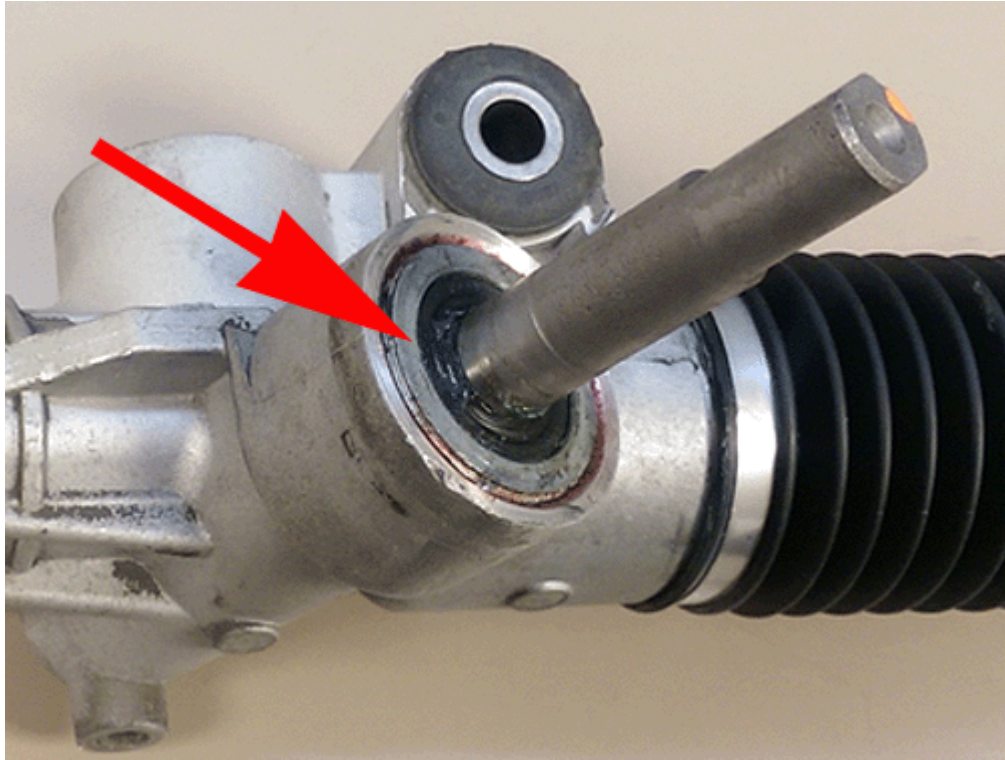
If the seal **is not** installed, proceed to the section below.

If the vehicle does not have the seal installed, replace the steering gear assembly. Refer to in SI.
