NUMBER: 05-005-04

GROUP: Brakes

Brake Shudder or Vibration

2004 - 2005 (HB) Durango

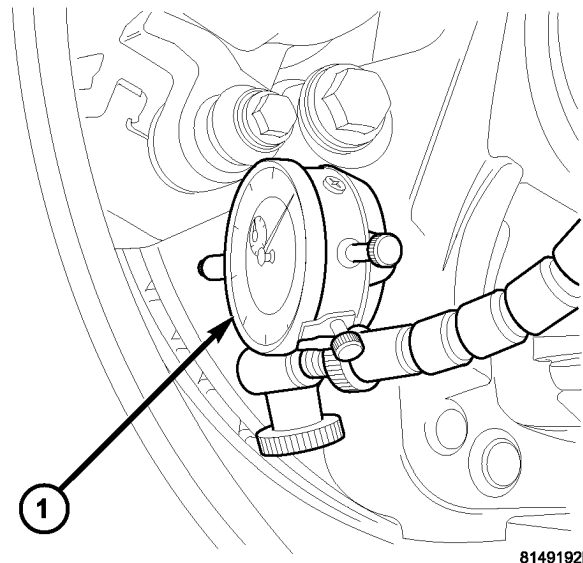
Fig. 1 ROTOR RUN OUT MEASUREMENT

8. Set up a dial indicator to measure mounted rotor runout. Place the dial indicator plunger against the inner machined rotor face, visible between the brake caliper and the front splash shield (Fig. 1). Rotate the wheel and tire assembly two turns and take runout measurement. If the measurement is less than .025 mm (.001 in.) no further action is required. If the measurement is greater than .025 mm (.001 in.) remove the lug nuts and relocate the wheel one stud clockwise, tighten the lug nuts as described in step 7 and check the runout again. Do not remove any brake parts. Repeat step 8 for each wheel location until you achieve the lowest mounted runout. Minimum mounted rotor runout will be achieved by moving the wheel, not the rotor.
