15216 – Propshaft U-joint Retainer Bolts Loss of Index

2015 Cadillac Escalade, Escalade ESV

2015 Chevrolet Silverado LD Crew and Double Cab

2015 GMC Sierra LD Crew and Double Cab, Yukon, Yukon XL

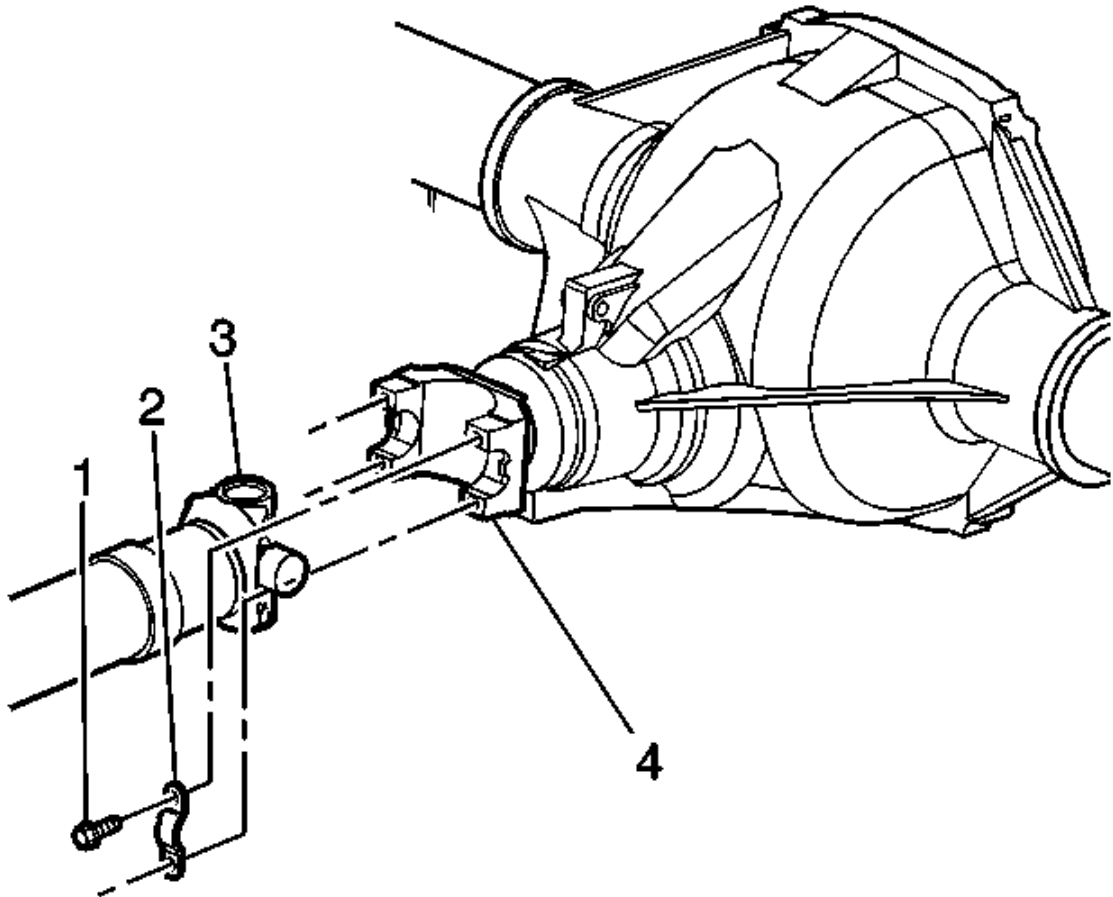
2.

Certain 2015 model year Cadillac Escalade and Escalade ESV; Chevrolet Silverado LD Crew and Double Cab; and GMC Sierra LD Crew, Sierra LD Crew Double Cab, Yukon, and Yukon XL model vehicles that are equipped with a 6.2L engine (RPO L86) and 8-speed automatic transmission (RPO M5U) may have a condition in which the u-joint retainer bolts lose index. If this condition occurs, the customer may hear or feel a “clunking” noise when changing speed. If this condition is not corrected, reduced clamp load may cause the propshaft to move relative to the axle yoke and the customer may feel a vibration. If one or more bolts back out completely, the propshaft may separate from the axle resulting in a loss of drive and potential damage to the underside of the vehicle.

Remove the two u-joint retainers (2) and four u-joint retainer bolts (1). Refer to in SI.

3. Discard the two u-joint retainers (2) and four u-joint retainer bolts (1).

4. Install two new u-joint retainers (2) and four u-joint retainer bolts (1). Refer to in SI. Tighten bolts to **25 Nm (18 lb ft)**.
