15401 – Service Update for Inventory and Customer Vehicles — Front Driver and Passenger Seat Plate Nut Thread Quality — Expires with Base Warranty

2015 Buick Enclave

2015 Chevrolet Traverse

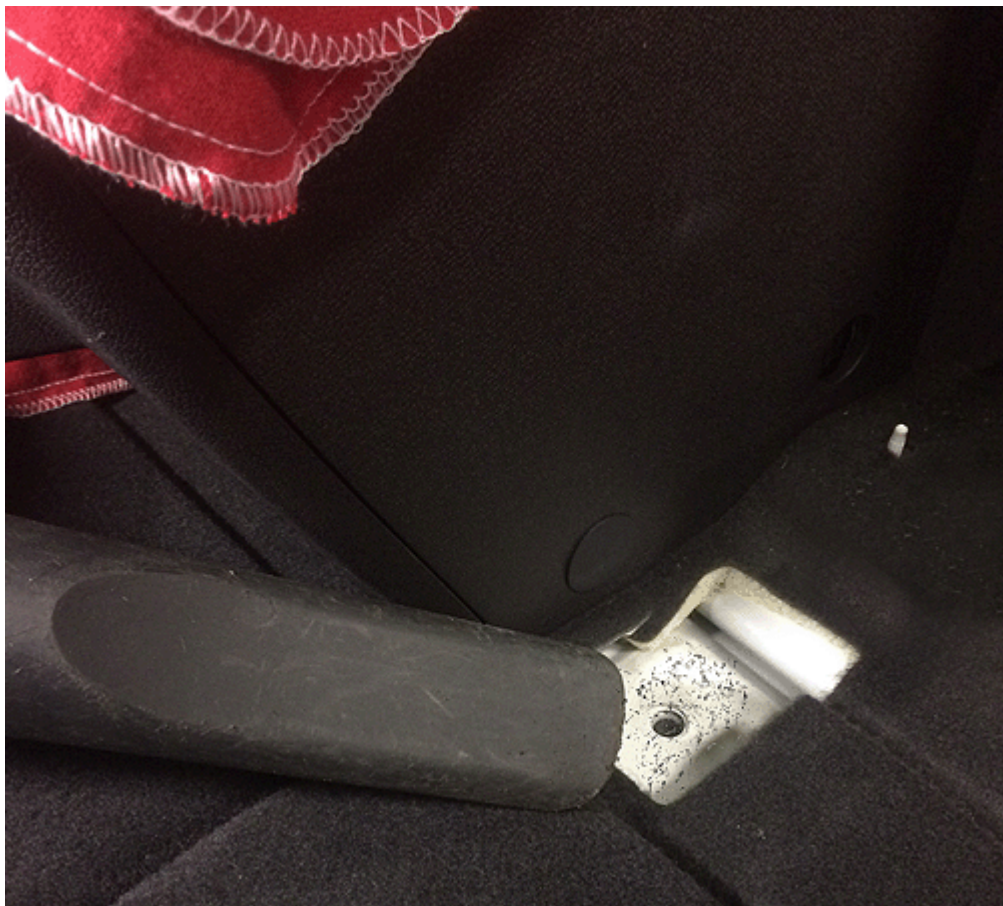
3.

Enlarging the holes requires drilling close to the center console. Use a compact drill to maintain a vertical drilling angle aligned to the holes.

Drill out the inboard seat track bolt mounting holes closest to the center console (one per seat) using the 11mm (7/16") drill bit keeping square to the holes.
