# Water Leaking on Front Right Passenger Floor During Hard Rain or Snow Melt Off When Vehicle is on an Incline

2011-2015 Chevrolet Cruze (includes Israel Export)

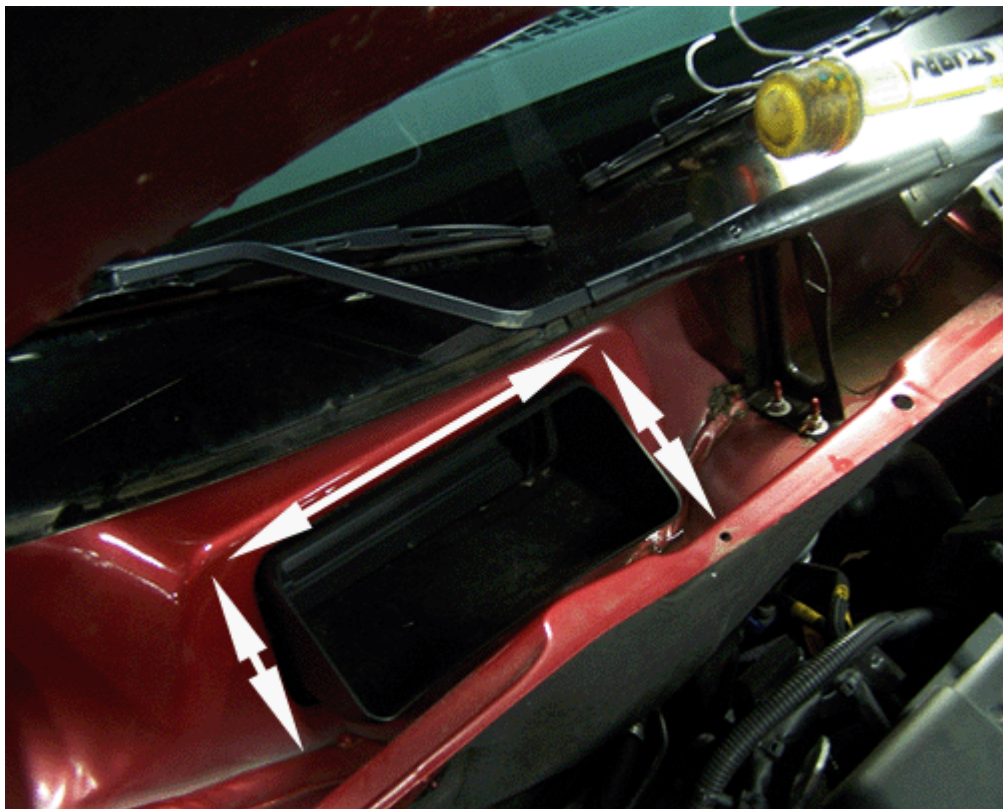
This condition may be caused by water running down the windshield under the air inlet grille panel, entering the body air inlet of the HVAC system.

1. Remove the passenger side air inlet grille panel. Refer to Air Inlet Grille Panel Replacement in SI.
