Poor Engine Performance P0089 P228D P0171 Whine Noise From High Pressure Fuel Pump

2010-2011 Buick LaCrosse

Equipped with 4 cyl engine (RPO LAF)

This PI was superseded to update Recommendation/Instructions. Please discard PIP5203B.

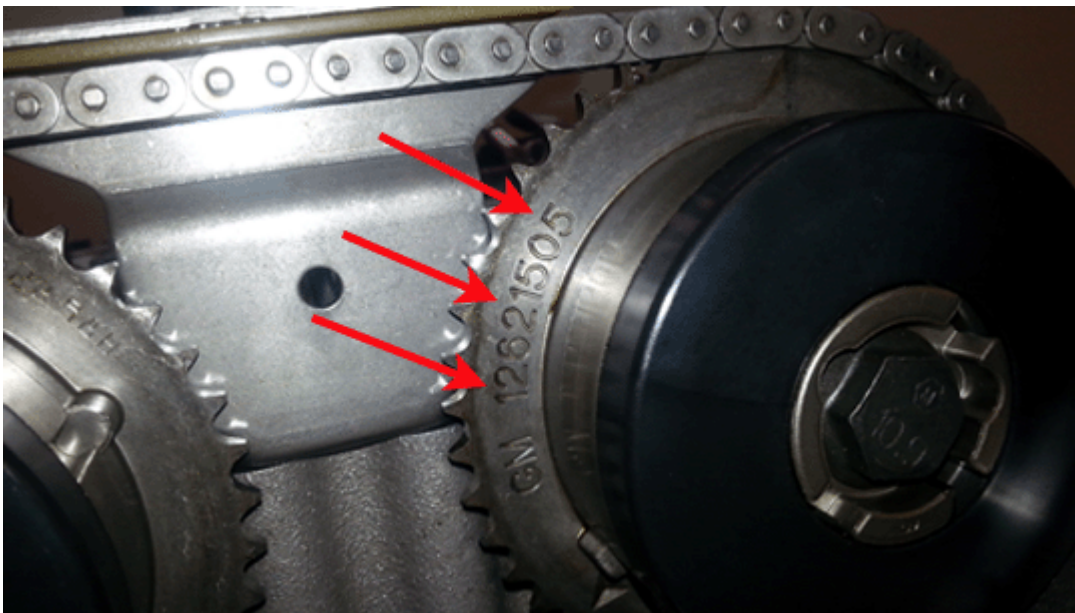
Below is an example of a 2011 Chevrolet Equinox intake camshaft actuator part number 12621505 and black in color (plastic cover piece).

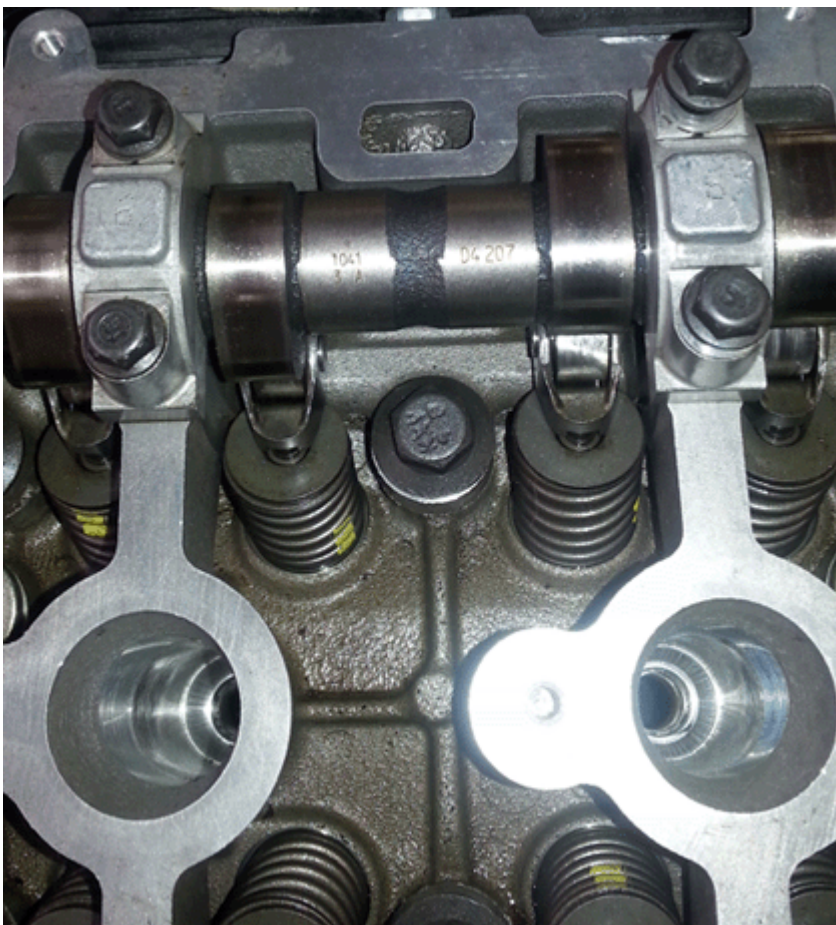
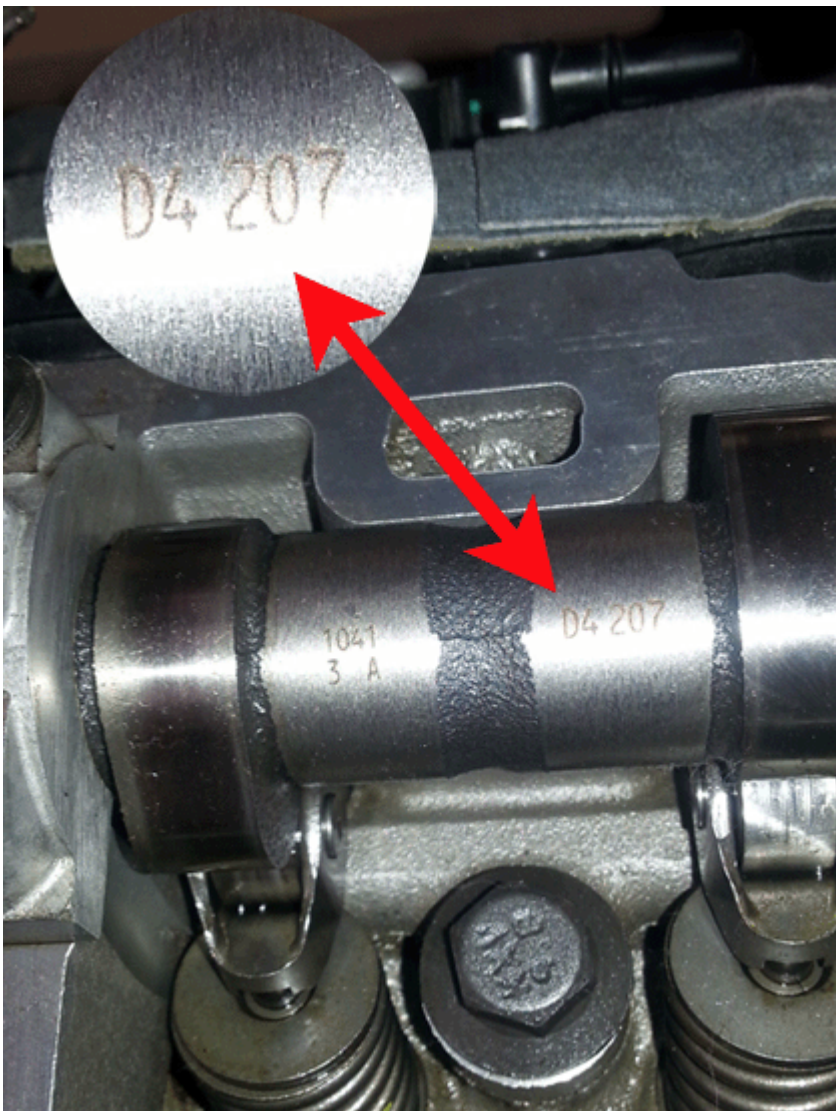
The camshafts can be identified by the last four digits of the part number located on a machined surface between the number 2 and number 3 cylinder camshaft lobes.

Below is an example of a 2011 Chevrolet Equinox intake camshaft part number 12634207.
