Diagnostic Tip - Clarification Of Vehicles Equipped With Fog Light (RPO T3U)

2014 - 2015 Buick Lacrosse

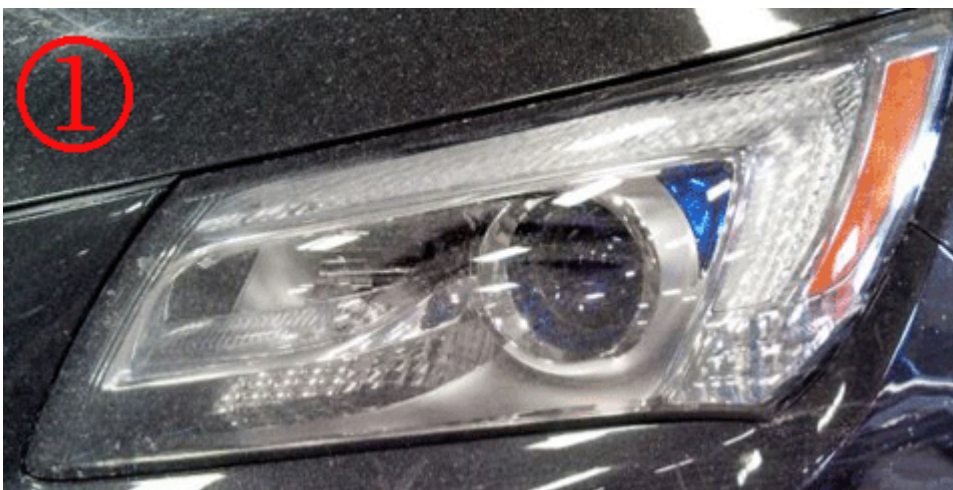
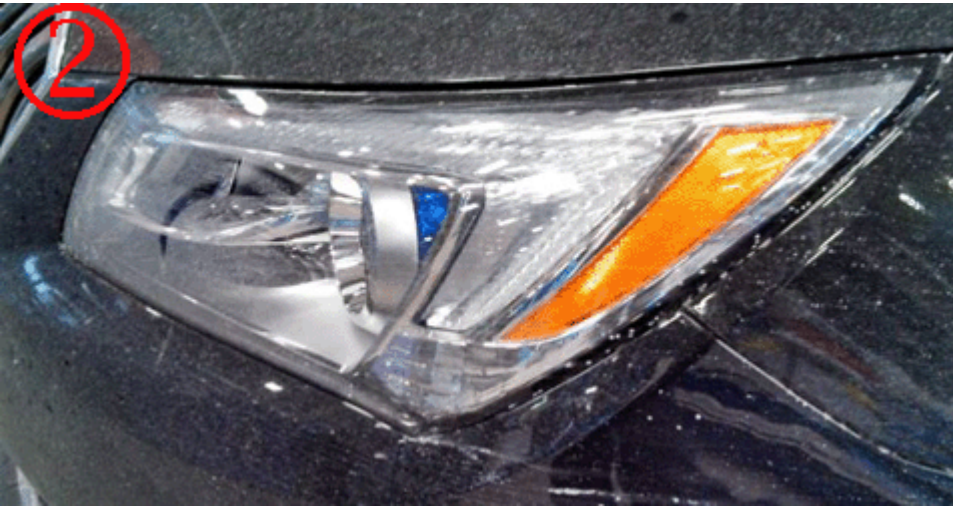
Vehicles equipped with RPO T4A (HEADLAMPS-HALOGEN) use the Lamps in the lower right / lower left portion of the Front Bumper Fascia as Daytime Running Lamps (DRLs).

BASE equipped RPO T4A (HEADLAMPS-HALOGEN) without (RPO T3U) Images 1 and 2.

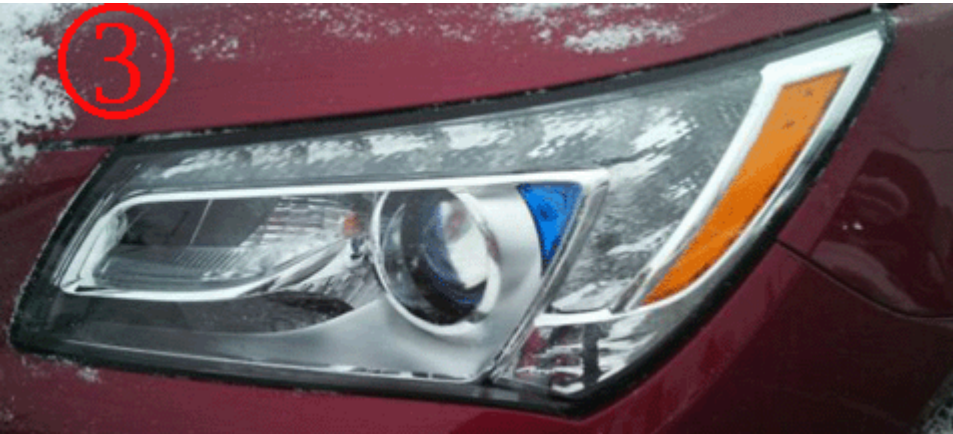
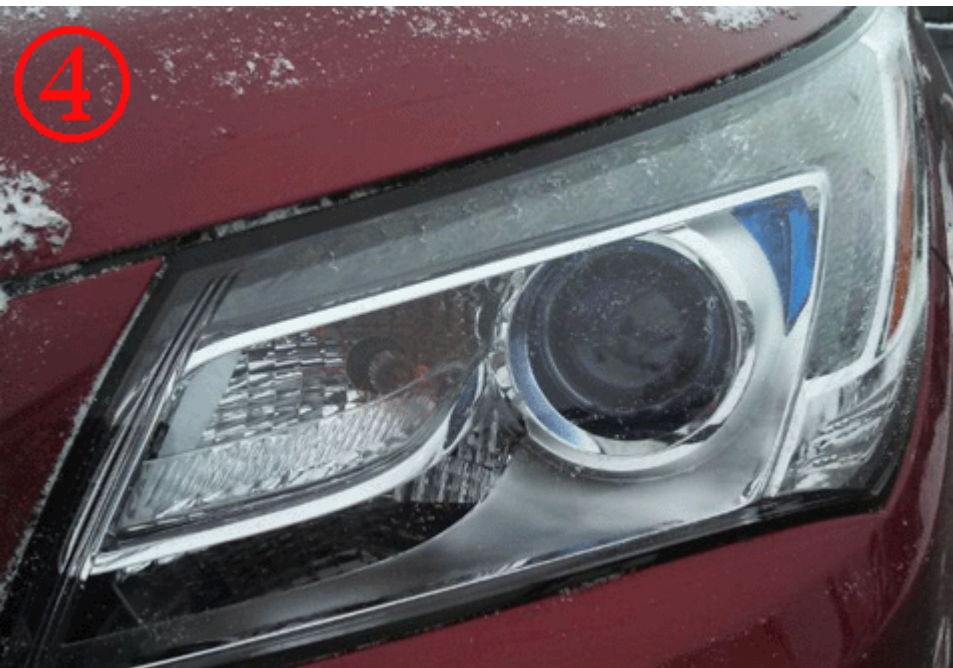
Both RPO T4A (HEADLAMPS-HALOGEN) and RPO T4F (HEADLAMPS-HIGH INTENSITY DISCHARGE) have hockey stick shaped lights as part of the headlight assembly.

Uplevel equipped RPO T4F (HEADLAMPS-HIGH INTENSITY DISCHARGE) Images 3 and 4.

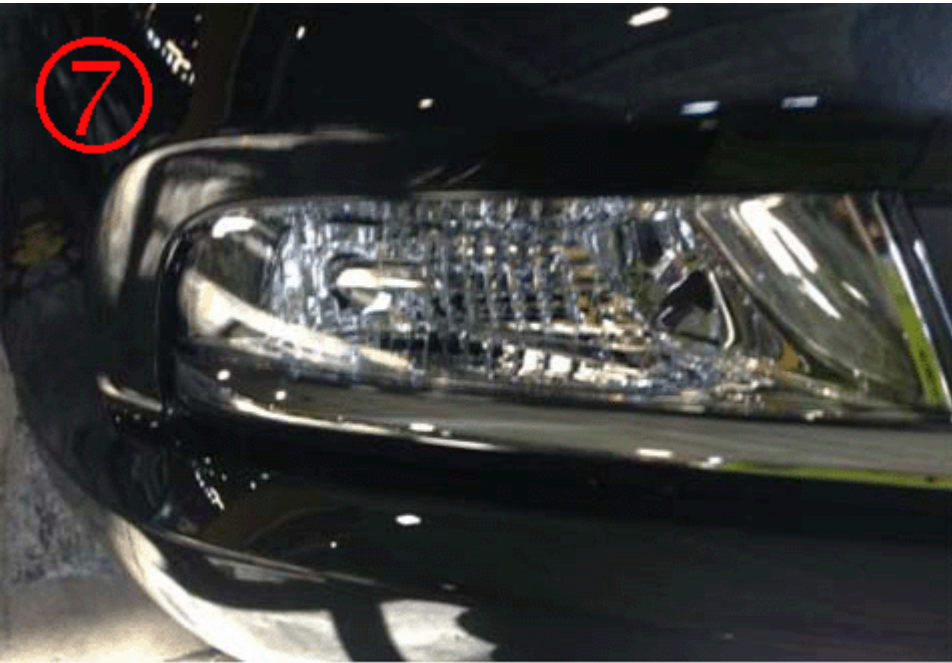
Daytime Running Light (base)

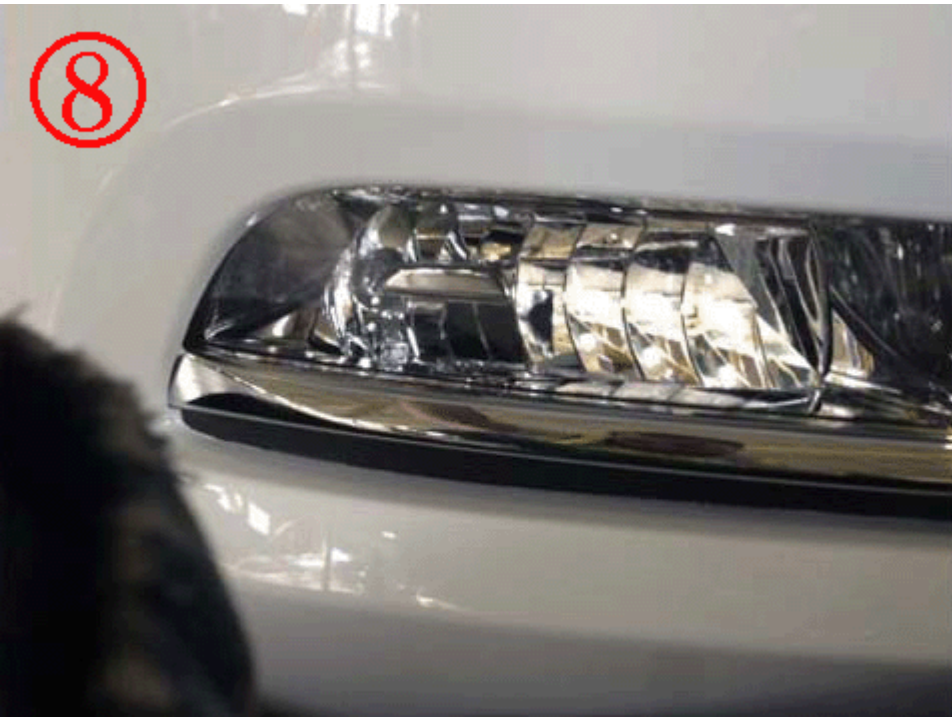
Fog Lamp (uplevel)

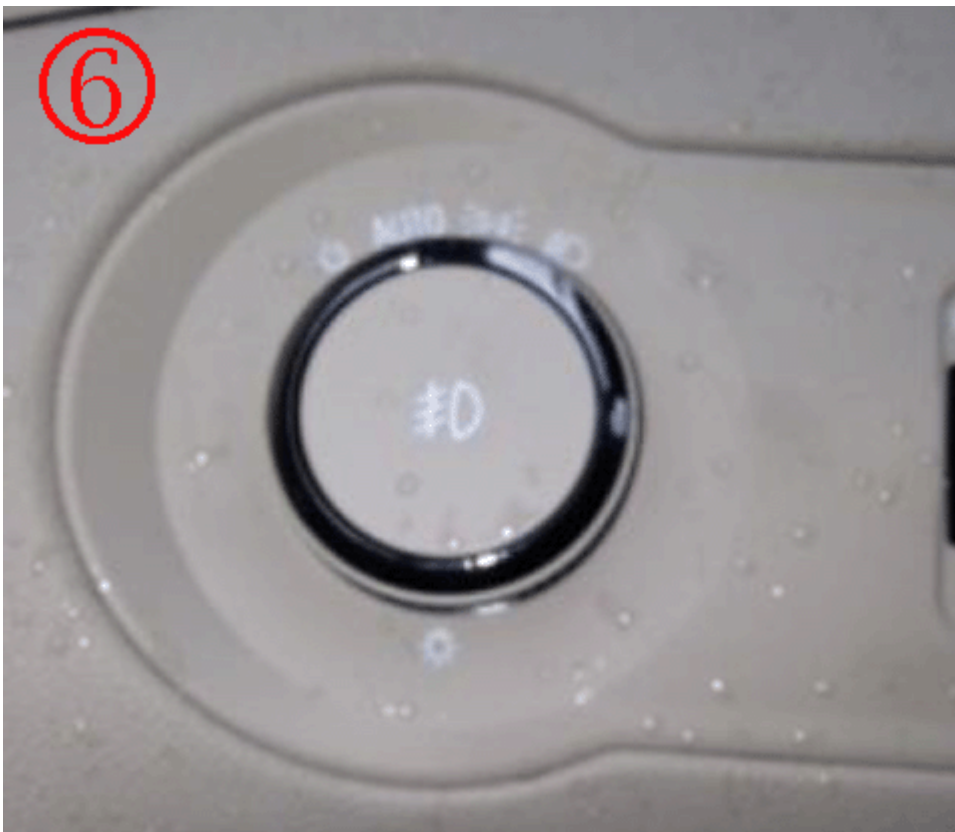
Fog Lamp Switch RPO T4F (HEADLAMPS-HIGH INTENSITY DISCHARGE and RPO T3U) is in the center of headlight switch.

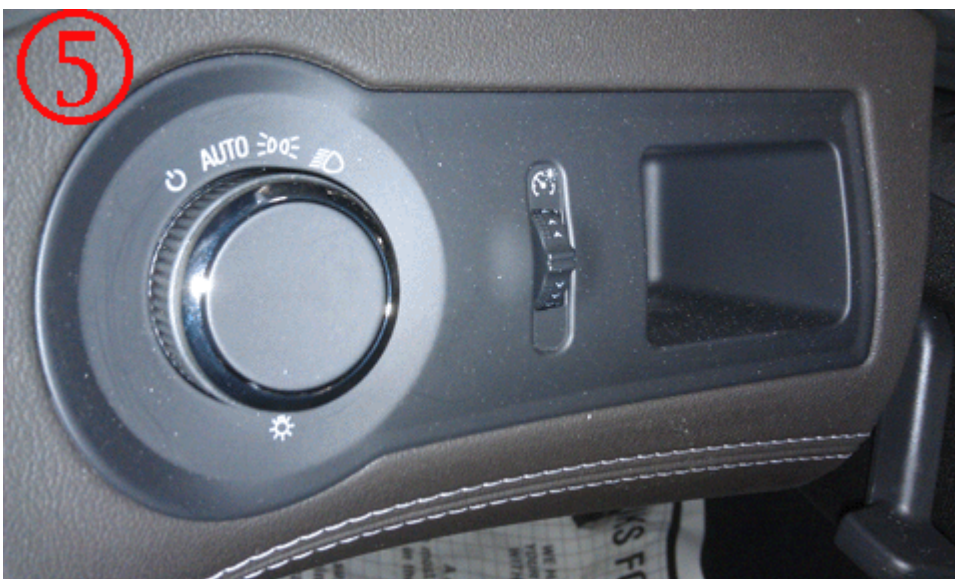
No Fog Lamp switch RPO T4A (HEADLAMPS-HALOGEN)

For vehicles not built with Fog Lamps (RPO T3U), please communicate to the customer this condition is a normal operating characteristic of their vehicle. Please share this information with the customer, including a copy of this message.
